AXC F 2152 – CHANGE NOTES

Change notes for the AXC F 2152 controller

Application note

108427_en_36

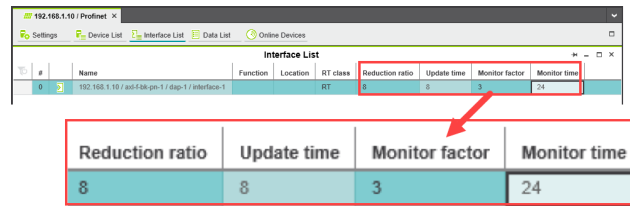
Figure 1 Monitor time

- Static_String array in C++ programs
The array sizes are incorrectly calculated in Static_String-type arrays (C++), meaning that access to the second element contained in the array and to those following is incorrect.
String arrays in IEC 61131 programs are not affected by this.
- AXC F 2152 as a PROFINET device
The AXC F 2152 cannot be operated as a PROFINET device under PROFINET controllers from third-party manufacturers.
- Monitor time of PROFINET data
The PROFINET data monitor time must be at least 24 ms. The monitor time is the product of “Reduction ratio” and “Monitor factor” (in PLCnext Engineer: “Profinet” editor group, “Interface list” editor).

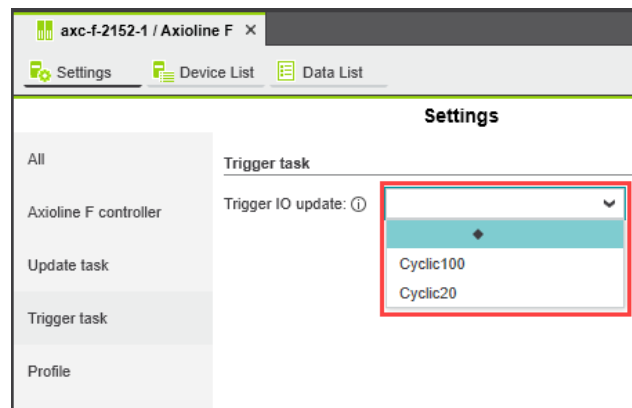
Figure 2 Select Trigger task

If you do not select a task, the update will occur by default every 50 ms.

- Select the “Trigger task” view in the “Settings” editor.
- In the drop-down list, select the task that is to trigger the Axioline F I/O data update.

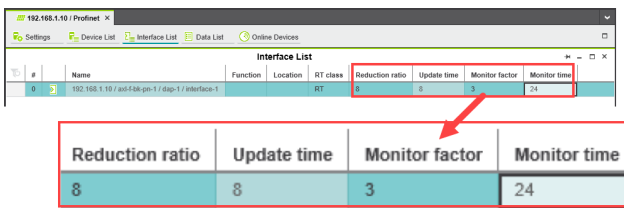
Figure 3 Monitor time

- Monitor time of PROFINET data
The PROFINET data monitor time must be at least 24 ms. The monitor time is the product of “Reduction ratio” and “Monitor factor” (in PLCnext Engineer: “Profinet” editor group, “Interface list” editor).
