# AXC F 2152 – CHANGE NOTES

## Change notes for the AXC F 2152 controller

Application note

108427\_en\_51

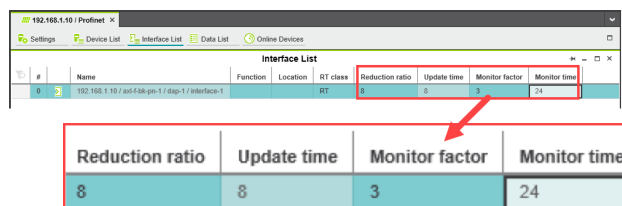
- Static\_String array in C++ programs  
The array sizes are incorrectly calculated in Static\_String-type arrays (C++), meaning that access to the second element contained in the array and to those following is incorrect.  
String arrays in IEC 61131 programs are not affected by this.
- AXC F 2152 as a PROFINET device  
The AXC F 2152 cannot be operated as a PROFINET device under PROFINET controllers from third-party manufacturers.
- Monitor time of PROFINET data  
The PROFINET data monitor time must be at least 24 ms. The monitor time is the product of “Reduction ratio” and “Monitor factor” (in PLCnext Engineer: “Profinet” editor group, “Interface list” editor).
